LYNCHWOOD LAKE DAM

NDI ID NO. PA-00773  
DER ID NO. 45-38

PHASE I INSPECTION REPORT  
NATIONAL DAM INSPECTION PROGRAM

JANUARY 1980

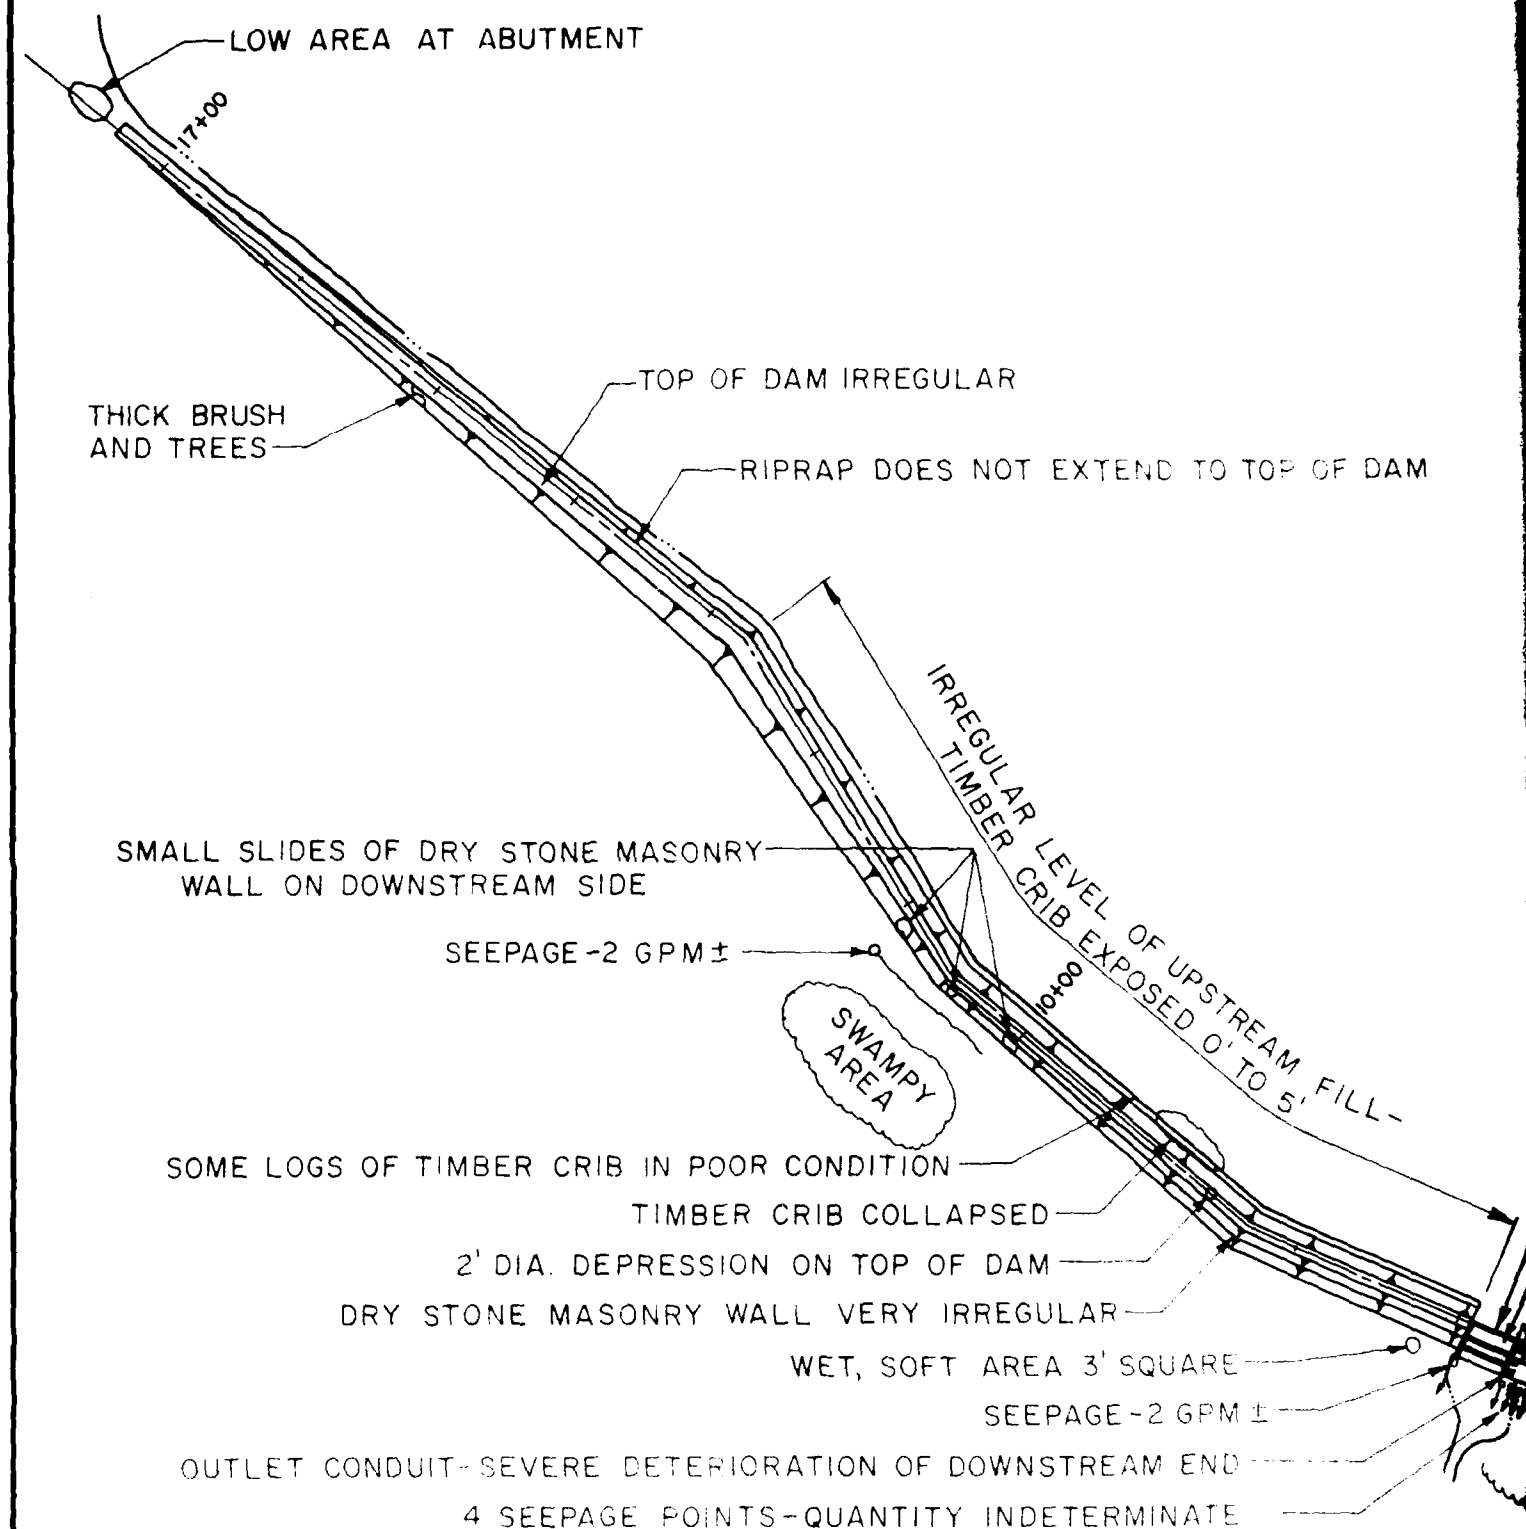
Clear seepage was observed at 10 locations along or near the downstream toe of the dam, particularly in the vicinity of the maximum section. The locations of the seepage areas and the approximate quantities of seepage are shown on Exhibit B-1. Several soft, wet areas were also located along or near the toe. The locations of those areas are also shown on Exhibit B-1.

ALL OBSERVED SEEPAGE WAS CLEAR.

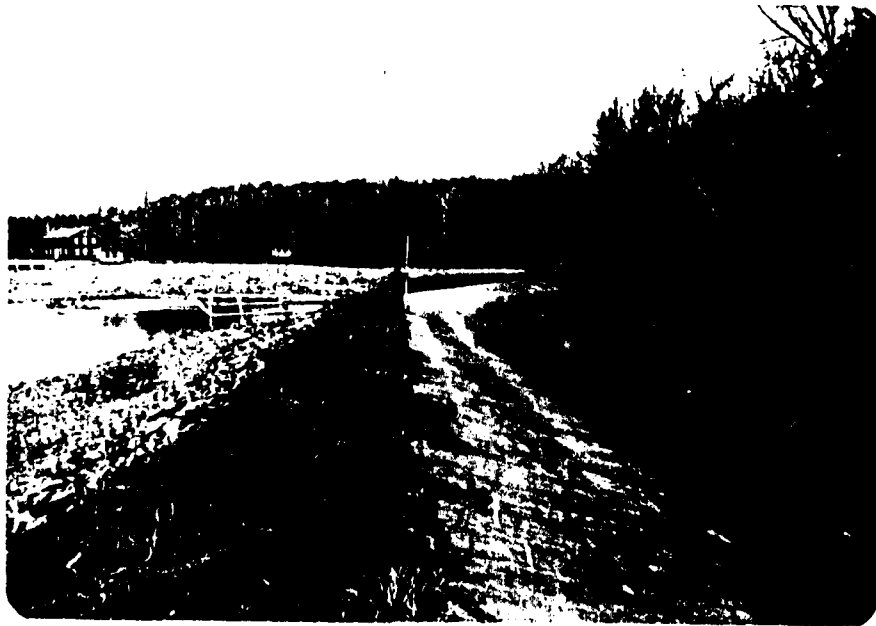
condition. The concrete lining on the downstream slope has a number of surface cracks, but no significant structural deficiencies were apparent. At the right abutment of the auxiliary spillway, there is a hole about 1 foot in diameter at the top of the embankment adjacent to the spillway sidewall. The sidewalls were lower than the adjacent embankment level. The auxiliary spillway has no defined outlet channel. It was observed that discharge would enter a wooded area and flow along a swale that is approximately parallel to the dam. Flow patterns would be complicated by an irregular pile of loose rock located about 30 feet downstream from the auxiliary spillway.

L. Auxiliary Spillway

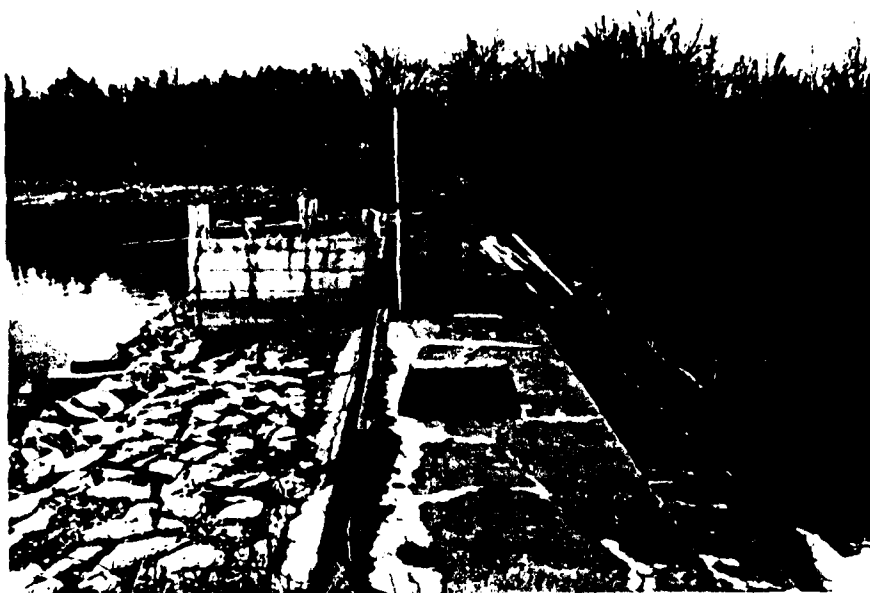
The outlet works is located along the left side of the main spillway. The intake structure is a timber and concrete structure located at the upstream side of the dam (Photograph M). Conduit flow is controlled by using wooden stoplogs at the intake structure. The intake structure appeared to be in good condition. The outlet conduit, a 36-inch diameter steel pipe, was in poor condition (Photograph N). Although flowing water prevented detailed inspection of the conduit, inspection from the outside indicated severe deterioration of its lower half for an estimated distance of 10 feet into the dam. No erosion was apparent at the bottom of the free overfall.

M. Main Spillway Crest and Outlet  
Works Intake Structure
